# EARLY 1911 PARTS *compared with* NEW 100TH ANNIVERSARY PARTS

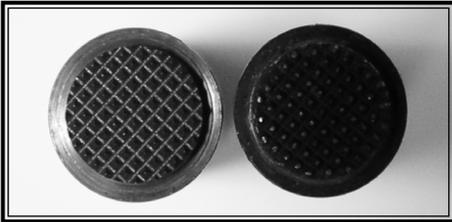
The new recoil spring plug is on the left and the original is on the right. The new one has very sharp diamonds on it and the original's diamonds are worn down so they look different. I am sure that the originals were sharp when new. In fact on original #305 that I examined the diamonds had obviously been filed down slightly to dull them except for the very diamond in the center and it was left sharp!

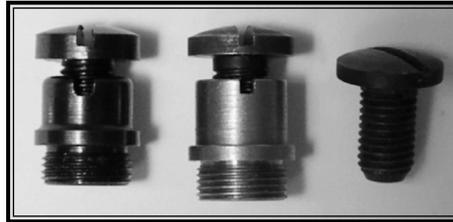
The grip screw and grip screw bushing for the early 1911 is in the center. The grip screw on the right is an original thin head grip screw. I did have an individual 1911 grip screw bushing that was not on a frame so I don't have one to show. The grip screw and grip screw bushing on the left is the later style. Note that the head of the grip screw is thicker and the grip screw bushing is shorter. You can also see that the screw driver slot in the new style grip screw is deeper than the slot in the early thin head grip screw. The shallow screwdriver slots were easily damaged so the government had the grip screw head made thicker which required that the grip screw bushing be made shorter.

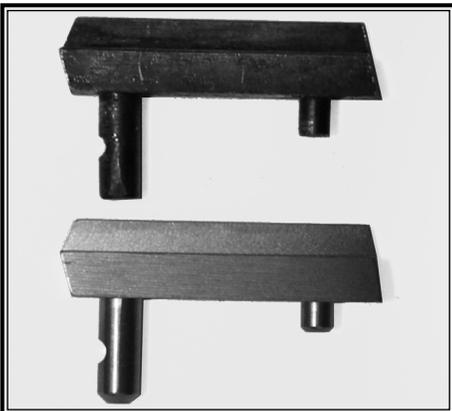
The new ejector is on the bottom. There were no changes from the 1911 to the 1911A1.

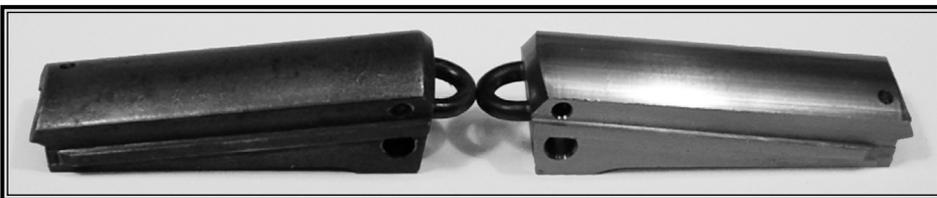
The new mainspring housing is on the right. I have noted that on the originals the mainspring housing and the frame were usually blended and buffed so much that the cross pin that holds in the lanyard loop is almost exposed. I have also seen where the top of the mainspring housing on an original flared out slightly to match the grip safety. That shows that the mainspring housing and the frames on the originals were assembled when they were blended and buffed.

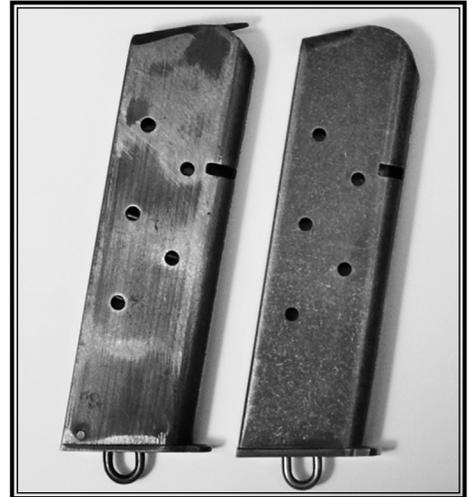
The new magazine is on the right. Recreating the original visible pinned base magazine has been very difficult. The magazine tubes on the original magazines were not heat treated so the holes for the rivets could be drilled in them after they were formed. The magazine tubes on our recreations are heat treated and cannot be drilled with a 1/16" hole after they are formed. I had to have the holes burned into each tube with a CNC EDM Sinker and those had to line up with the holes in the floor plates!! Also remember that there are 6 rivet heads that have to be formed on each magazine, 2 for the lanyard loop and 4 for the floor plate rivets.

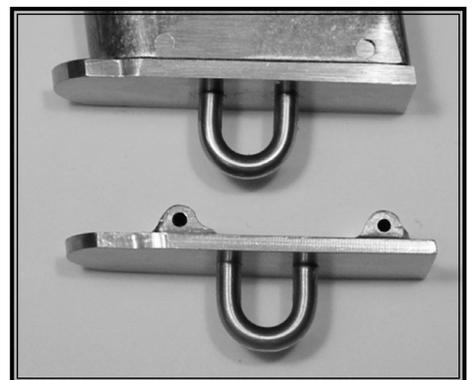
This is a picture of the new magazine with a floor plate assembly below it. Note that the toe of the floor plate has to be machined to match the rounded contour of the front of the magazine.
